Swanage Railway Trust 4TC project update - Spring 2024

Trailer Brake Standard Corridor (TBSK) 70824

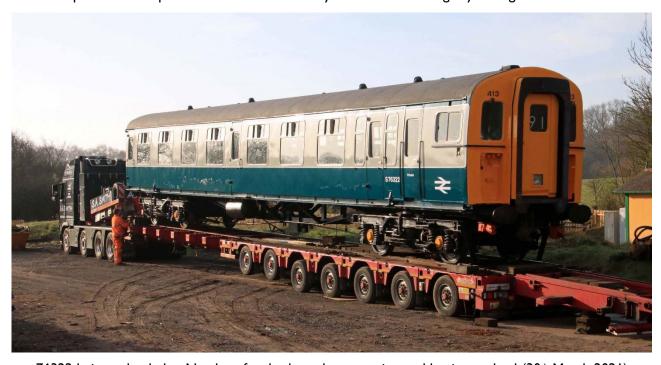
76322 being unloaded at Norden after bodywork restoration and bogie overhaul (30th March 2021)

Since our last major update 76322's bodywork and bogie restoration at Rampart was completed and the coach returned to Swanage at the end of March 2021. This coach is now in storage at Harmans Cross awaiting its turn on the lifting jacks at Swanage to complete the repairs to cable and pipework theft damage on the underframe. Fortunately, we have most of the materials required for this work in stock. We also need to fit tarpaulins to this coach at some point soon to prevent the overhauled bodywork from suffering any damage or deterioration.

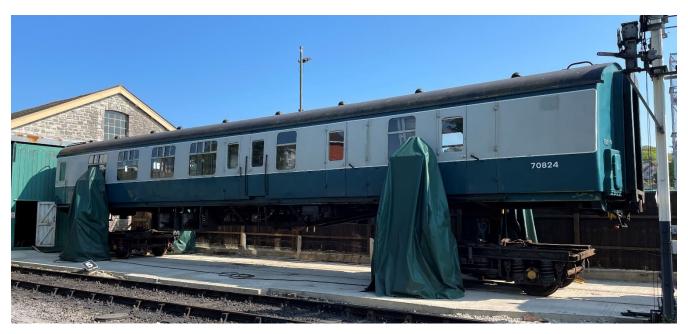
TBSK 70824 lifted off its bogies (13th May 2023)

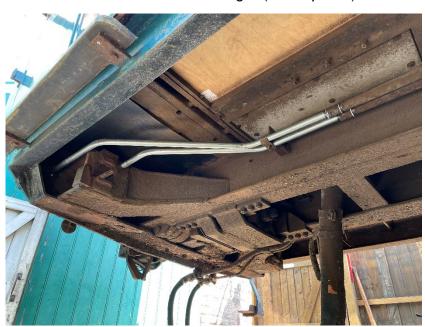
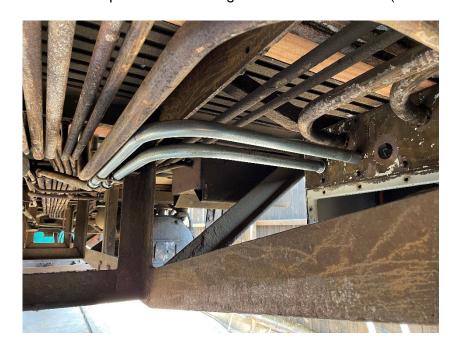
New conduit fitted to replace sections damaged when cable was stolen (above and below)

- Vehicle lighting wiring examined and tested.
- ETH power cables replaced due to being stolen.
- End to end control, lighting and heating wiring completely replaced due to be stolen or damaged.
- Auxiliary control cubicle over 75% new rewired.
- Significant replacement of wiring conduit due to damage caused during theft of wiring.
- Replacement batteries fitted.
- Compartment heater conduit and wiring replaced due to corrosion.
- Jumper sockets rewired and fitted.
- Compressor examined and repaired.
- Motor Generator set examined.
- High voltage electrics tested off a shore supply with compressor and motor generator both working for first time in at least 23 years. Heaters that are still fitted worked too.
- PA system tested.

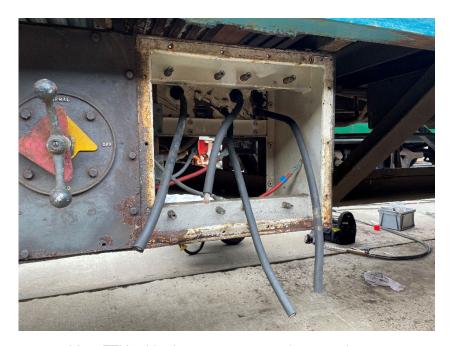
New ETH cables being run in to auxiliary supply case

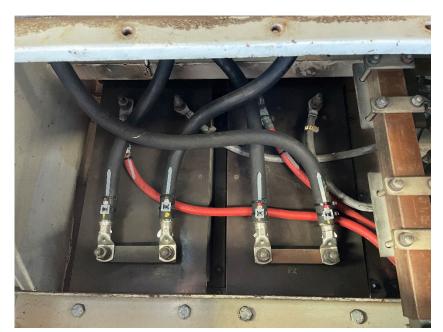
New ETH supply cables terminated in rear of supply case

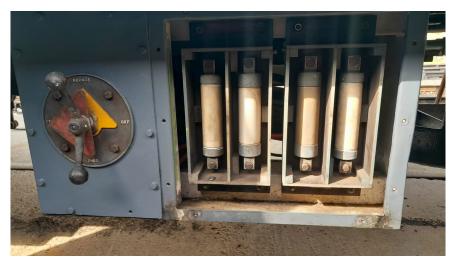
Finished supply case after welding repairs to damage front completed

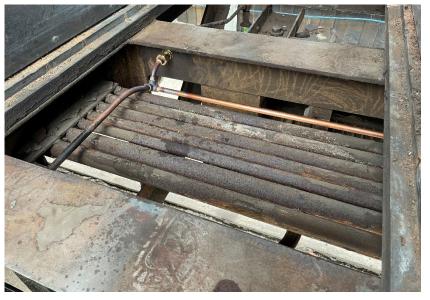
New brake pipework fitted to replace stolen sections

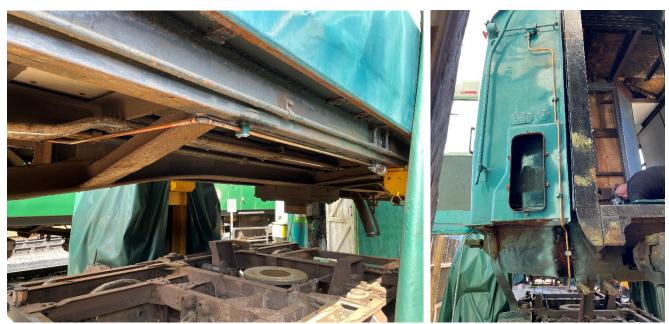
More new brake pipework fitted to replace stolen sections

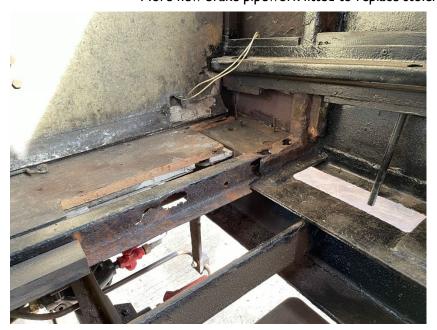
Before and after welding in new floor "top hat" support section

- Compartment floors and bearers repaired or replaced as required.
- Toilet floor repaired.
- Corridor floor and bearers repaired or replaced as required.
- Walls between compartments and toilet repaired as required.
- New floor support "top hat" sections welded in as required.

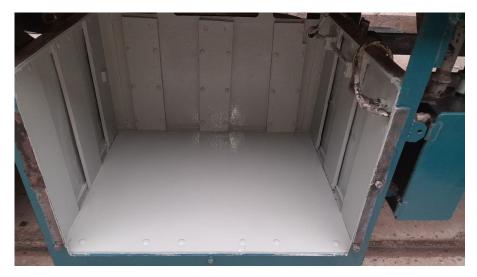
Battery box after rebuilding

- Battery boxes repaired.
- Entire underframe cleaned and painted.
- Gangway faceplates needle gunned and painted.
- Shore supply switch box repaired.

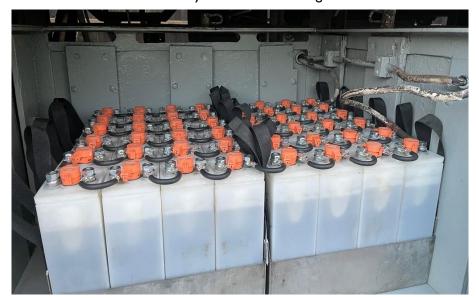
Replacement batteries fitted (ex-Class 442!)

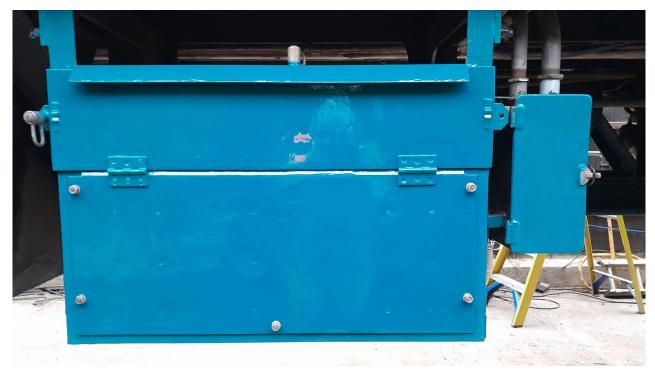
Finished battery box

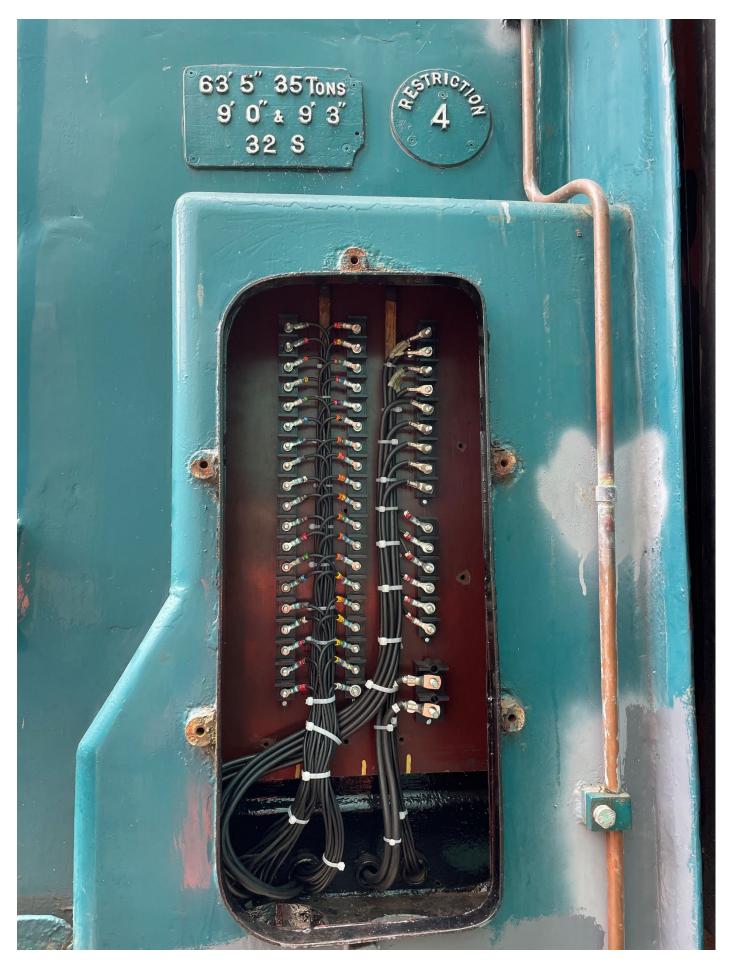
New terminal rails and mouting board installed, and new 27-way control wiring and heating wiring terminated

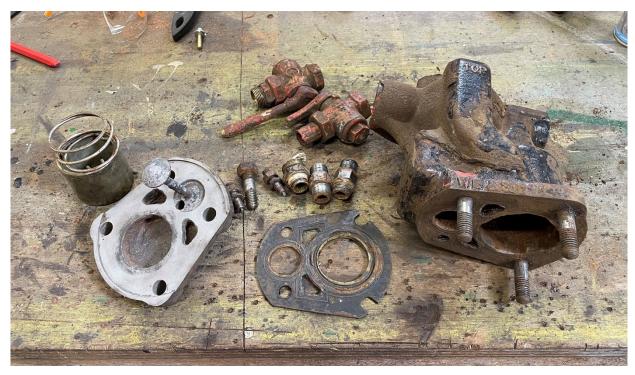
Air filter/strainer stripped for overhaul

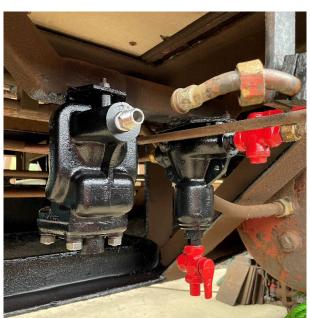
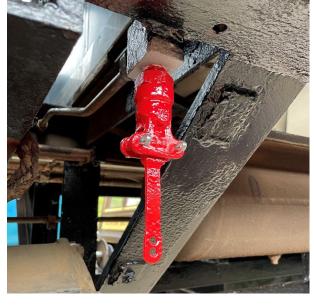
Overhauled air filter/strainer

Overhauled brake release valve

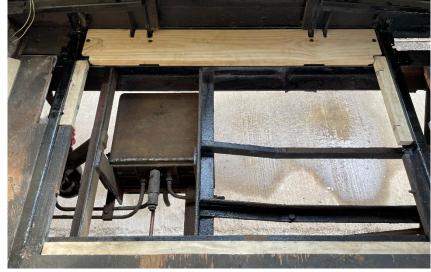
Compartment floor bearers being replaced

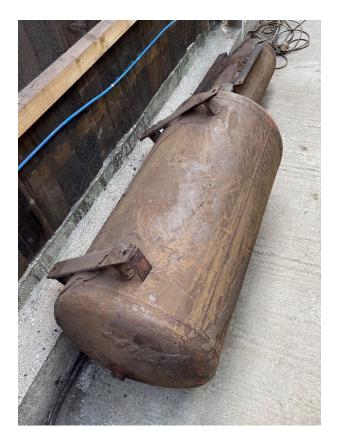
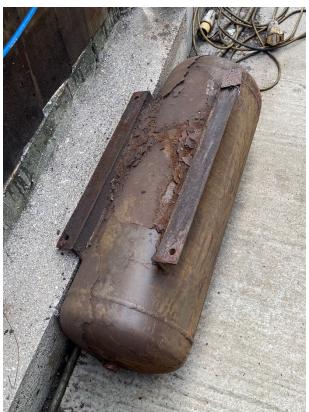
Old air reservoirs after removal – both subsequently failed testing due to corrosion

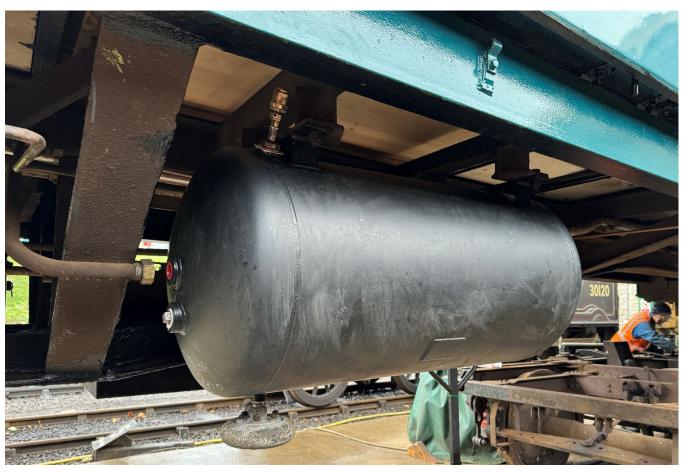
\pounds 2,900 later and we had two new air reservoirs ready to fit. Fortunately, one of our regular volunteers offered to sponsor their fabrication thus avoiding depleting our funds

- Replacement air reservoirs made by contractor and fitted.
- Air system water/dirt filters overhauled.
- All isolating cocks overhauled.
- Damaged and stolen pipework replaced approximately 50% of pipework.
- System pressure tested.
- Faulty compressor governor replaced.

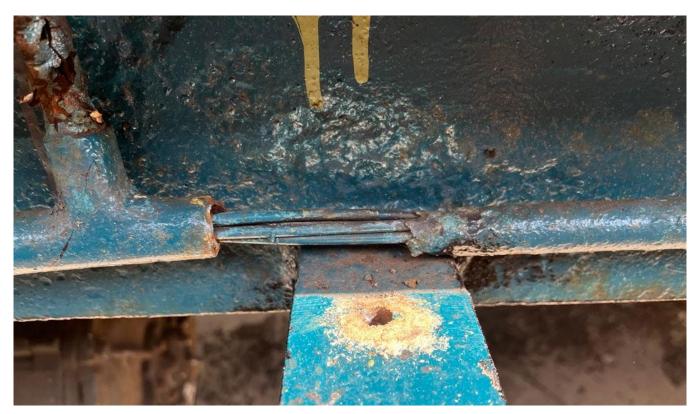
Old compartment heating conduit and wiring – as you can see it had seen better days!

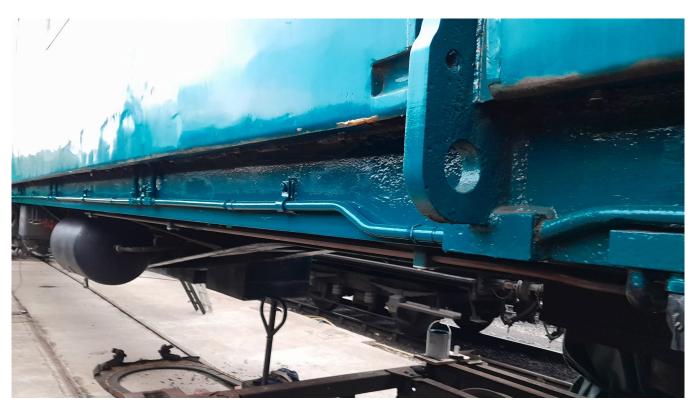
New compartment heating conduit and wiring installed

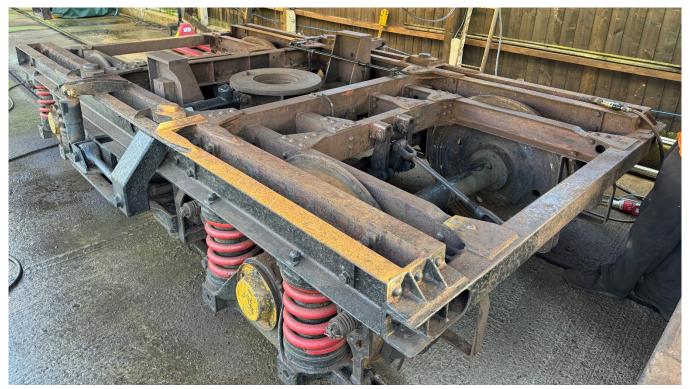
Bogie during needle gunning to remove old paint and rust

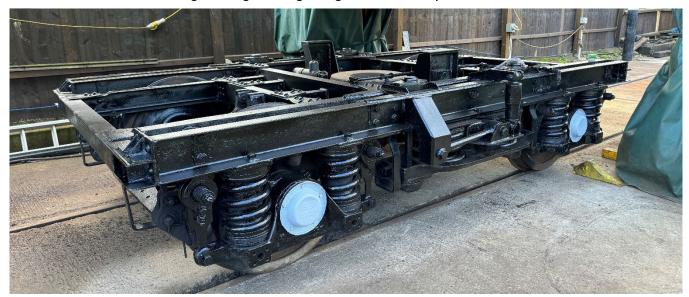
Bogie after spraying black with anti-corrosive paint

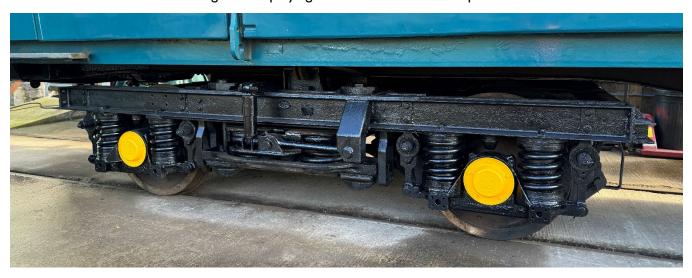
And finally, yellow axlebox covers

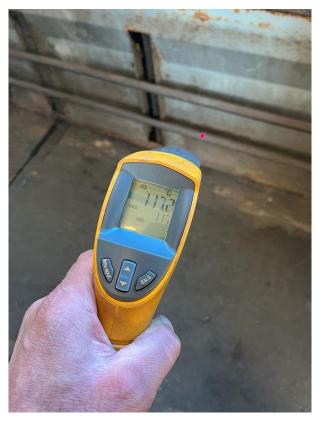
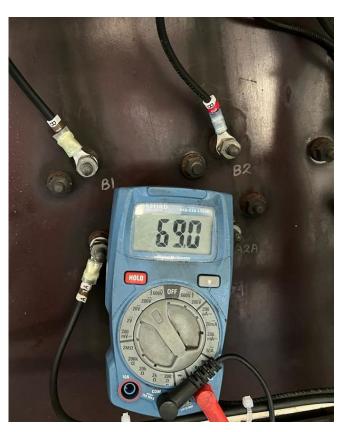
Measuring the output from the Motor Generator

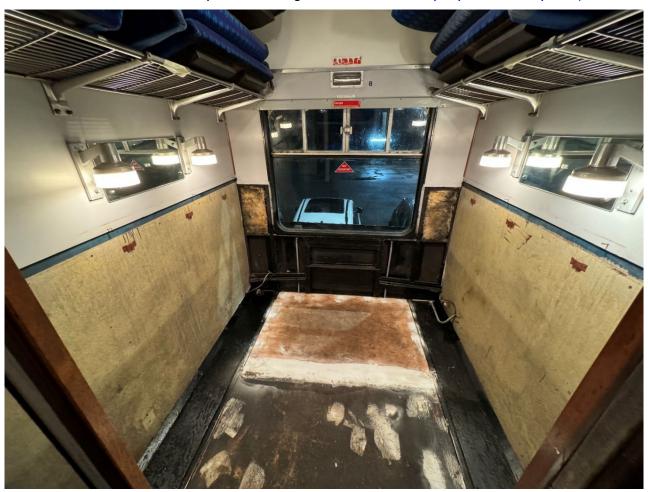
One of the compartments showing the repaired floor awaiting linoleum, and the refurbished reading lights being tested.
